Groundwater Report

Fall 2022

San Joaquin County

Flood Control and Water Conservation District

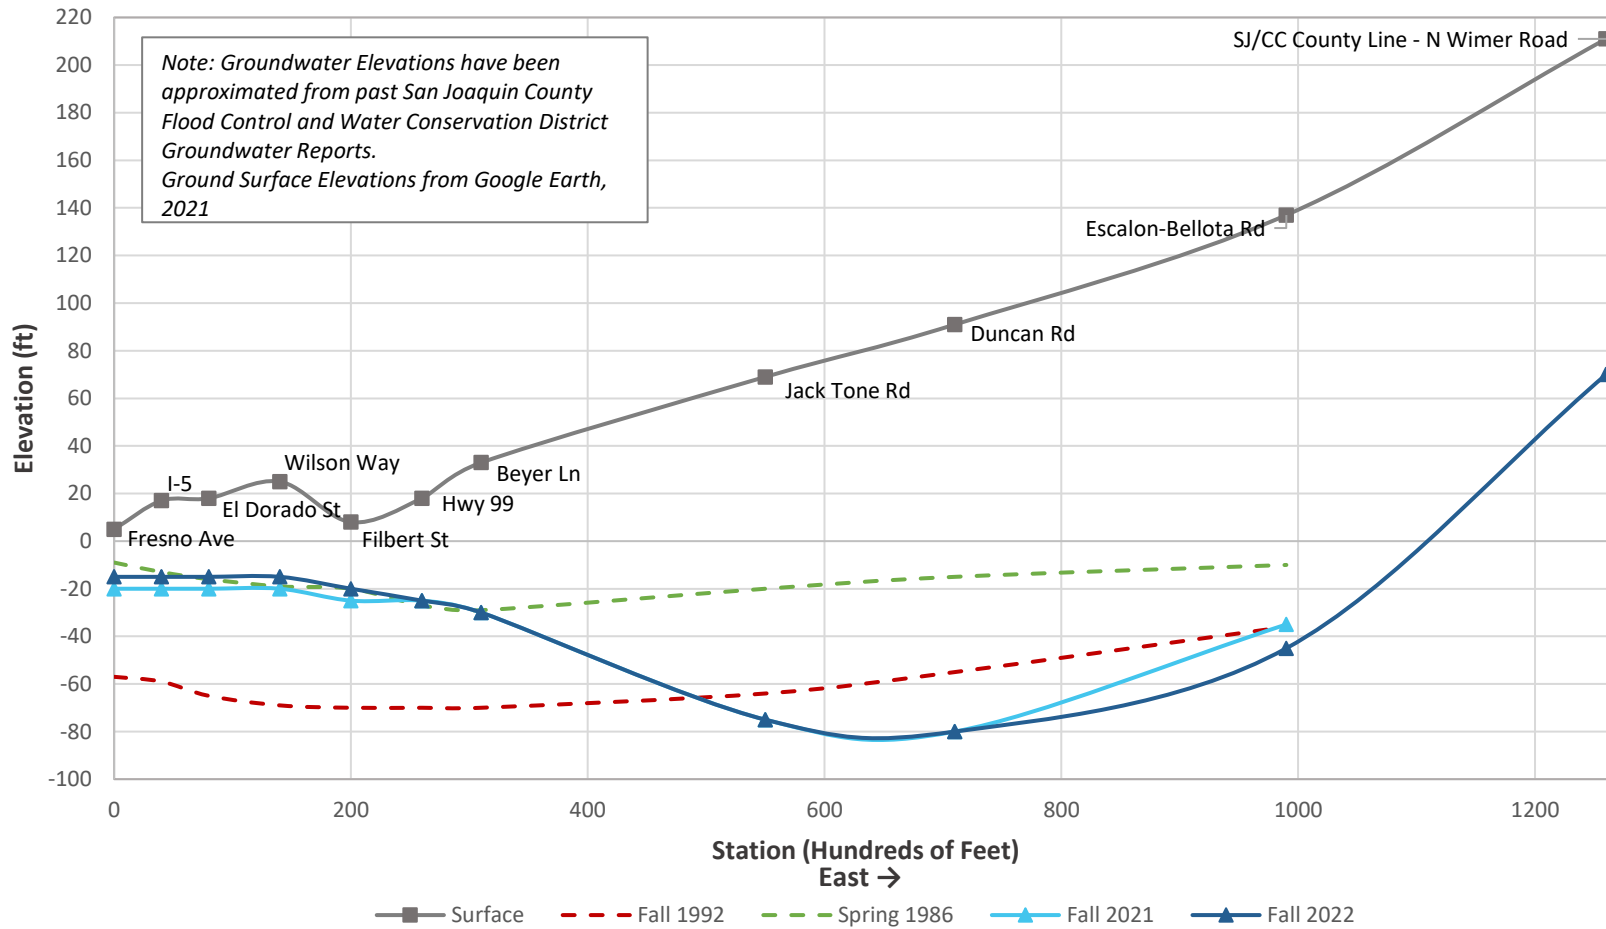
Figure 4-30 Highway 4 & Highway 26 Cross Section Fall 2022

Groundwater level profiles were developed to illustrate the relationship of where groundwater levels were increasing or decreasing in relationship to Spring 1986, the historic high groundwater levels, and Fall 1992, historic low groundwater levels. Figure 4-28 shows the location of the profiles and Figures 4-29 through 4-31 provide the profiles.
